Recovery procedure for Digi RF products

This article is an all-inclusive guide for recovering a Digi RF product that is in an unresponsive state. Please click on the type of radio you are experiencing problems with to go to the appropriate section:

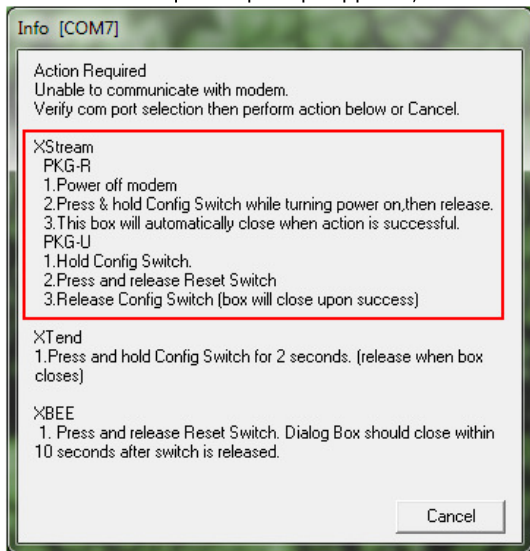
1. Open X-CTU and go to the Modem Configuration tab.
2. Click the *Restore* button.
3. If an "Action Required" prompt appears, follow the directions listed in this window.

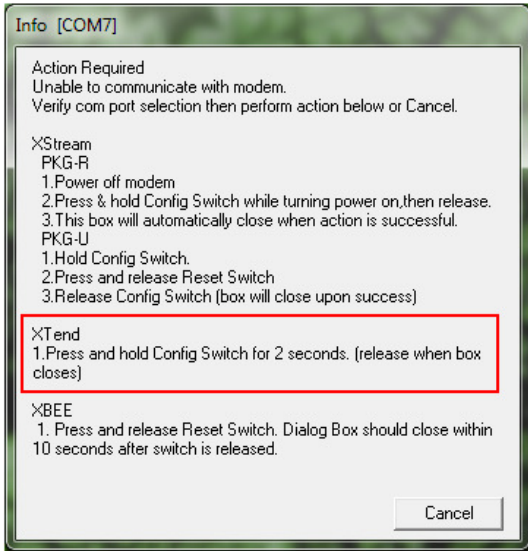
1. In PC Settings, select a baud rate of 9600 and set flow control to NONE.
2. Go to the Modem Configuration tab.
3. Click the *Restore* button.
4. If an "Action Required" prompt appears, follow the directions listed in this window:

5. You will know it succeeded if the last line of the status prompt located at the bottom of the window says "Write Parameters..... Complete"

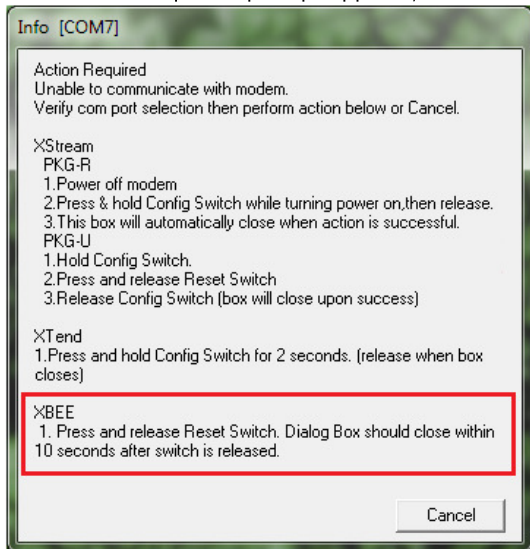
1. In PC Settings, select a baud rate of 9600 and set flow control to NONE.
2. Go to the Modem Configuration tab.
3. Click the Restore button.
4. If an "Action Required" prompt appears, follow the directions listed in this window:

5. You will know it succeeded if the last line of the status prompt located at the bottom of the window says "Write Parameters..... Complete"

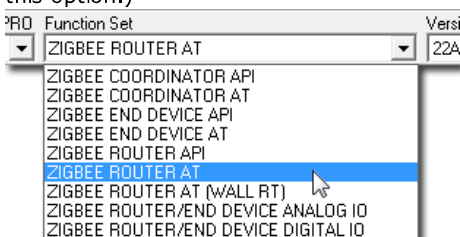
4. For the Function Set, select "ZIGBEE ROUTER AT" (Even if you need a different function set, it's best to attempt a recovery using this option.)

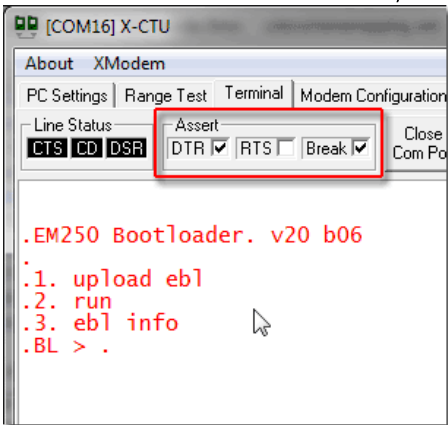
1. In PC Settings, set the baud rate to 115200. This is the baud rate of the bootloader on the radio.
2. Open the terminal tab.
3. Check the *DTR* and *Break* checkboxes, clear the *RTS* checkbox.

4. Press the reset button on the interface board.
5. Uncheck *Break* (leave *DTR* checked.)
6. Click in the blank terminal window to give it focus and press the [Enter] key on your keyboard.
7. A menu should appear with the title of EM250 Bootloader. This means that the radio is functional and we can easily enter bootloader.

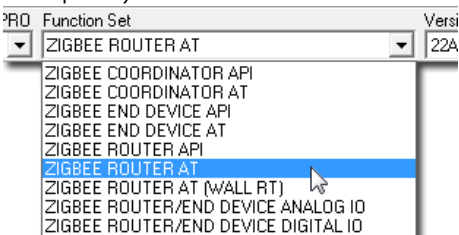
3. For the Function Set, select "*ZIGBEE ROUTER AT*" (Even if you need a different function set, it's best to attempt a recovery using this option.)
